Property

649 Wood Dr.
Glenview, IL 60022

Date & Time

02/01/2019 1:00 pm

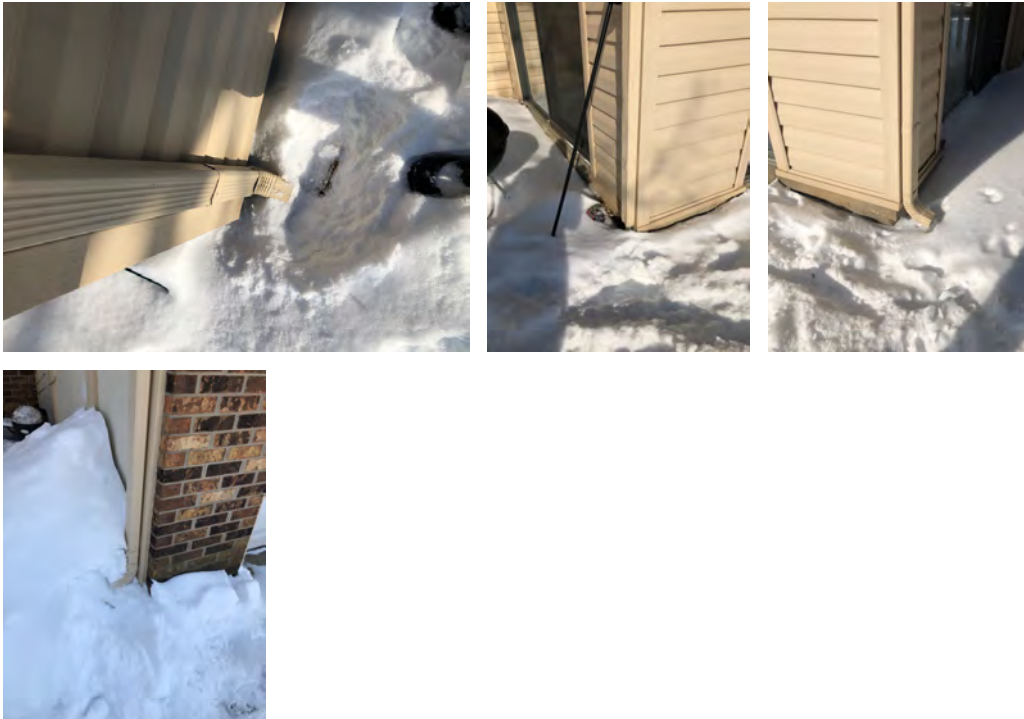
Roofing

Downspouts should extend a min of 4-6' from the structure to reduce the risk of water penetration, settlement and structural damage. Evidence of water infiltration noted in crawlspace.

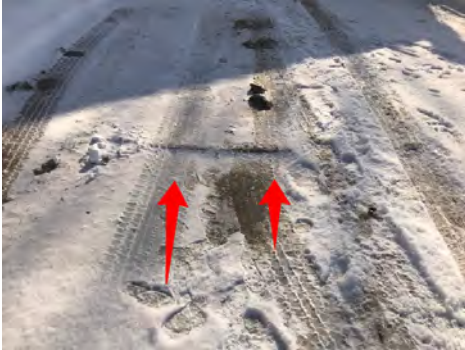
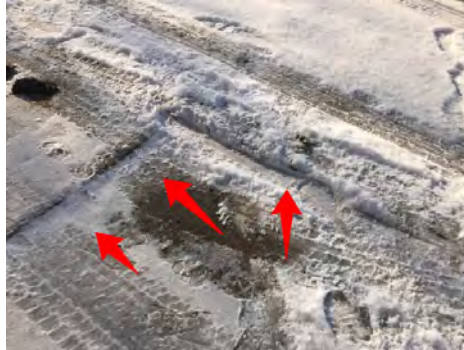
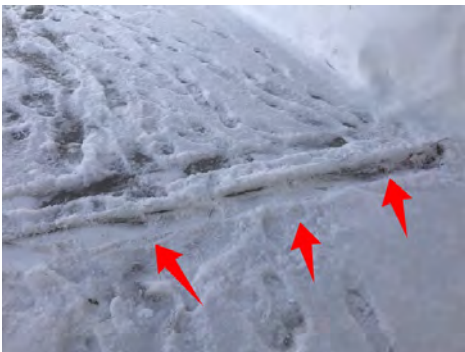
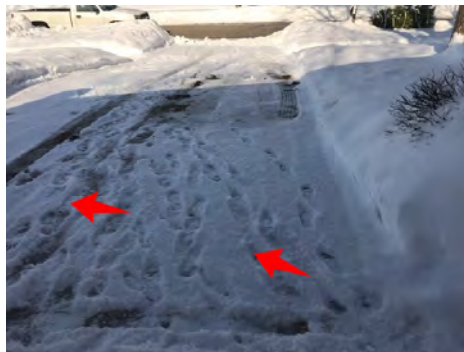
Grounds

The driveway expansion joint that separates concrete slabs are not sealed properly. Resulting in movement of the slabs due to frost heaving and becoming a trip hazard.

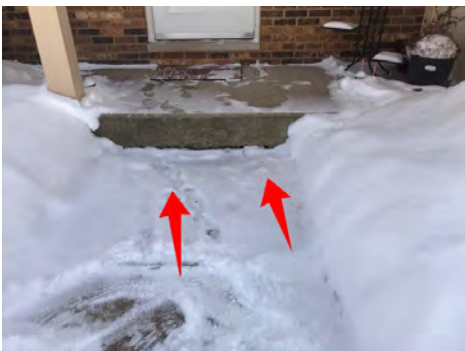
Grounds

A negative grading in front walkway of the home is leading water towards the front stoop and foundation.

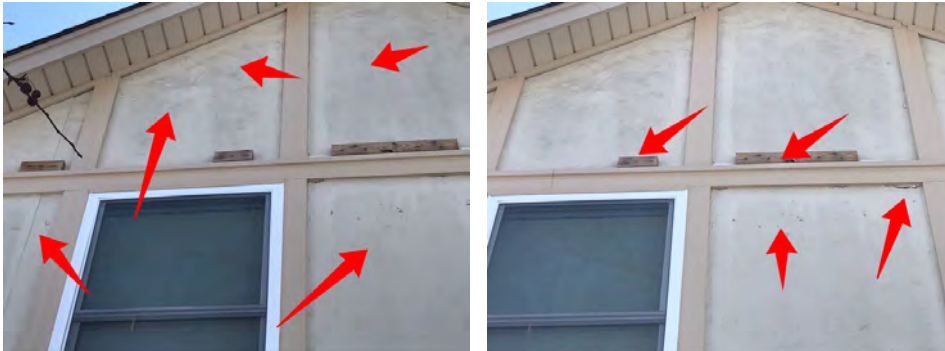
Exterior

Damage to the front stucco and wood planks (2" x 4") are nailed to front stucco. We

Recommend having a licensed professional to evaluate before closing. See attic section.

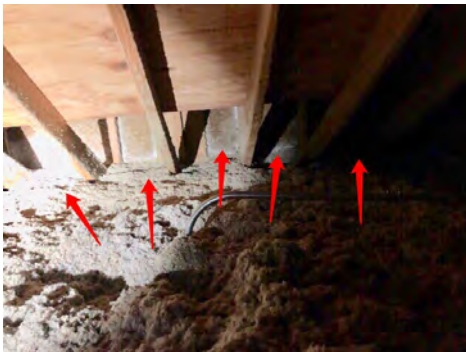
Structure: Attic

There is frost buildup on the front wall of the attic. Damage to the front exterior in this area has been temporarily repaired with 2x4 boards. We recommend the front of the home and this section of attic be evaluated for repair by a qualified building contractor to prevent further water damage.

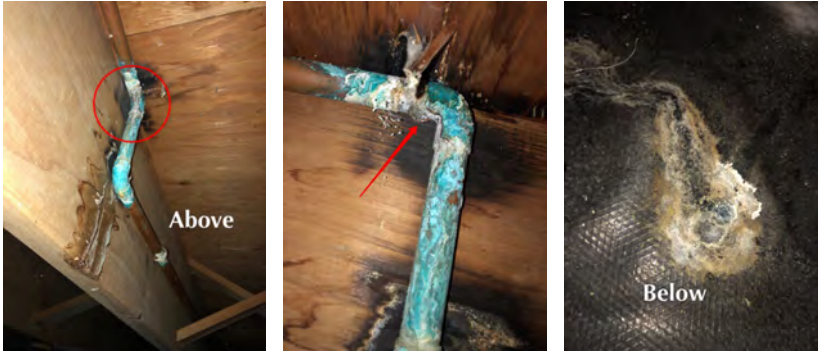
There is an active leak and heavy corrosion on a copper water supply pipe in the south central part of the crawlspace. We recommend all water supply fittings in the crawlspace be evaluated by a licensed plumber. Active leaks should be repaired promptly.

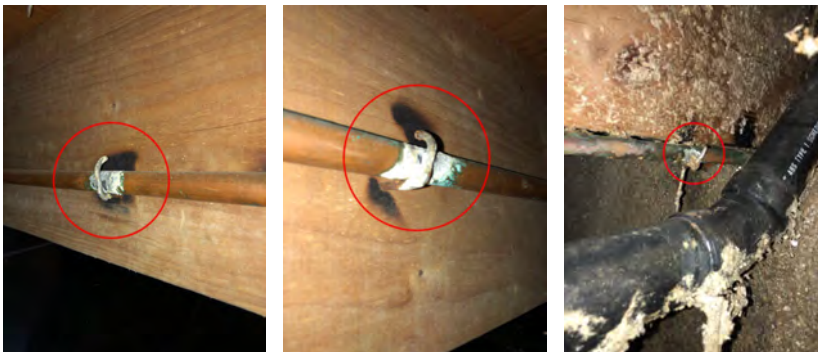
Structure: Crawlspace

There is galvanic corrosion on the water pipes at numerous joints and fasteners. We recommend all visible water pipes be evaluated by a qualified plumber. Any improper hangers should be replaced with correct ones to reduce the risk of electrolysis and eventual leaks.

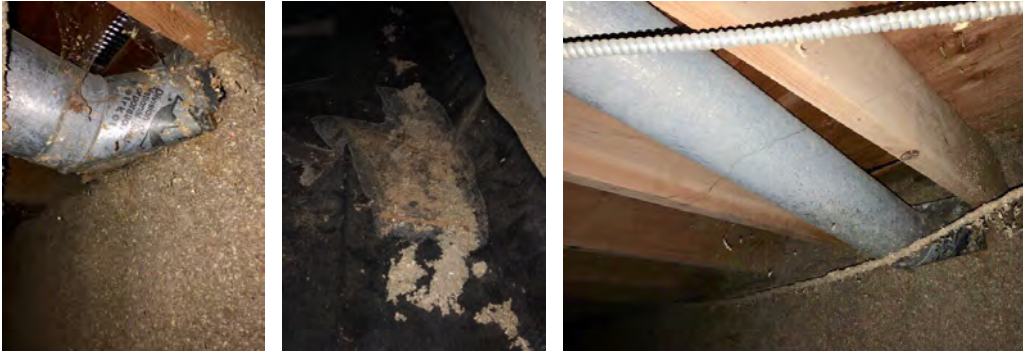
Structure: Crawlspace

There are loose, poorly supported and uninsulated HVAC ducts in the crawlspace. Signs of water below ducts can indicate poor management of condensate runoff. We recommend ductwork be evaluated by a licensed HVAC professional. See comments on HVAC "distribution" section of report.

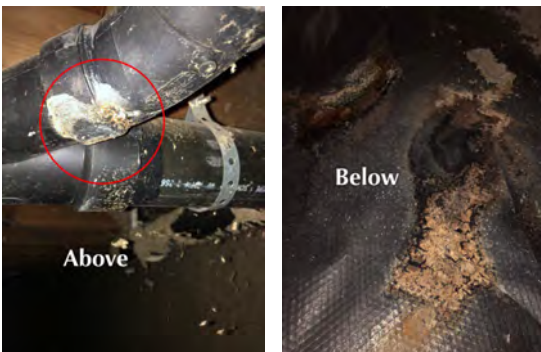
Structure: Crawlspace

There is a leak at a union in the black waste line in the crawlspace. We recommend evaluation for repair by a qualified plumber.

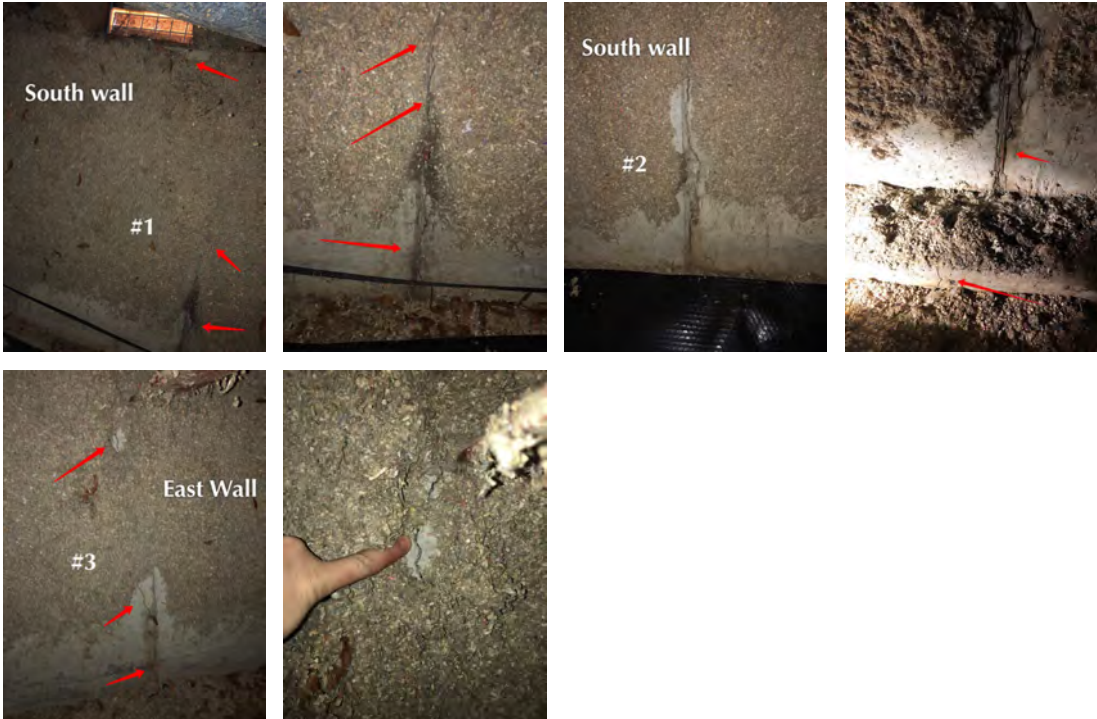
Structure: Crawlspace

There are 3 or more cracks in the foundation. These should be evaluated for repair by a qualified basement waterproofing/structural professional.

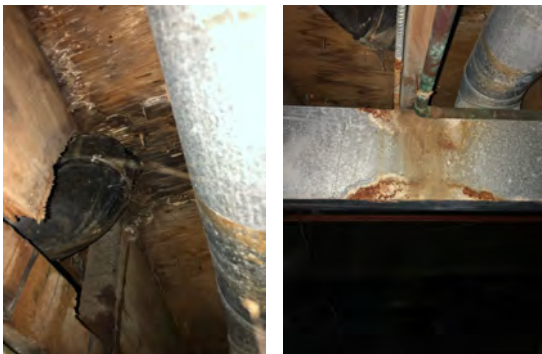
Structure: Crawlspace

The main floor toilet is loose and leaking on to the HVAC ductwork below. We recommend repair by a qualified plumber and professional cleaning of the ductwork.

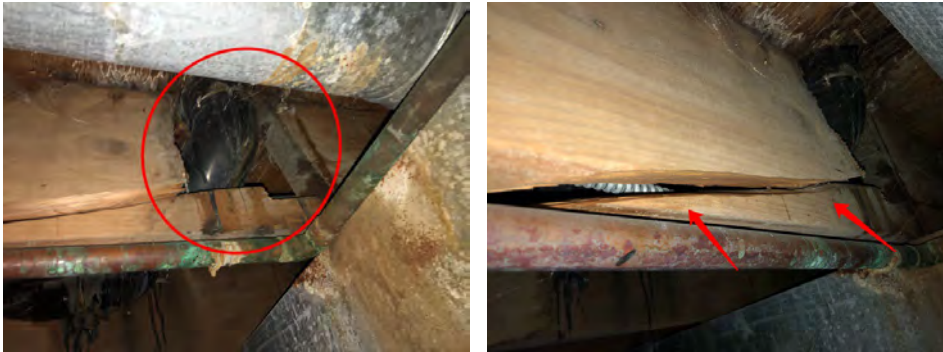
Structure: Crawlspace

The joist below the main floor toilet has been improperly notched to accommodate the waste drain. The remaining joist has split through. This should be evaluated by a qualified building contractor prior to repairs of the toilet.

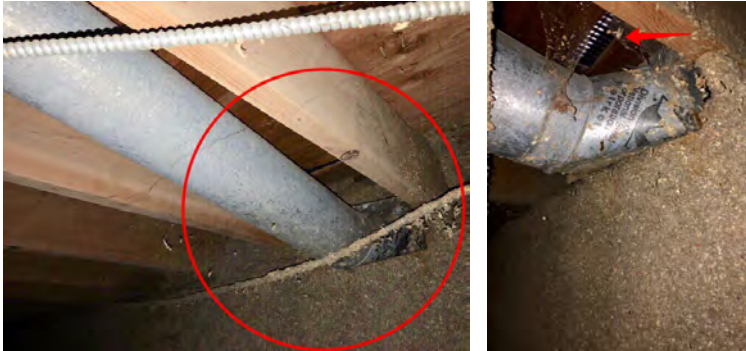
One of the supply ducts in the crawlspace is not correctly installed. Conditioned air is being supplied to the crawlspace rather than the kitchen heat register above. We recommend the ductwork in the crawl space be evaluated by a HVAC professional.

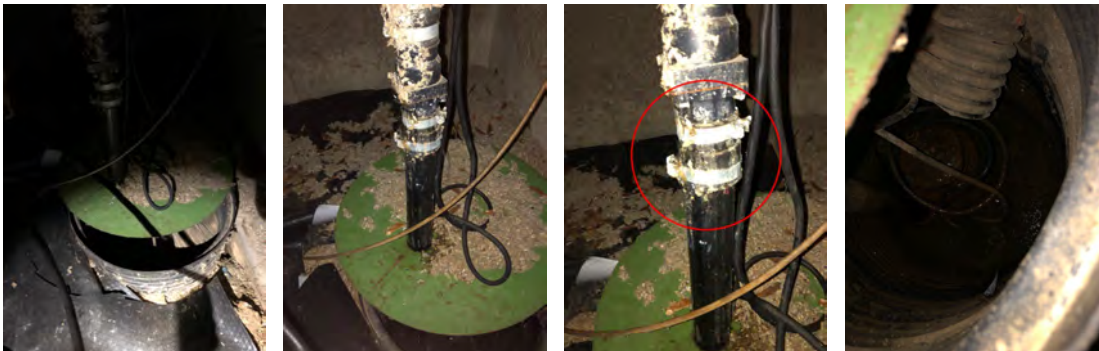
Plumbing

The check valve in the sump drain line is leaking.

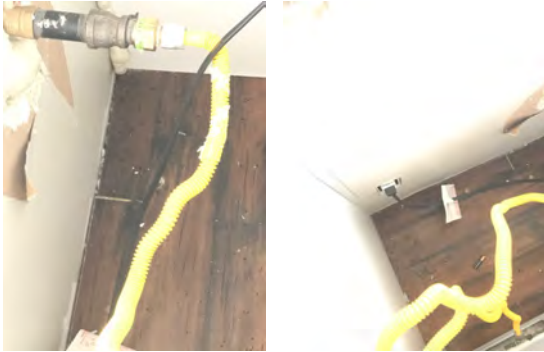
Signs of rodents /mice dropping behind the stove. Recommend having a licensed exterminator to evaluate.

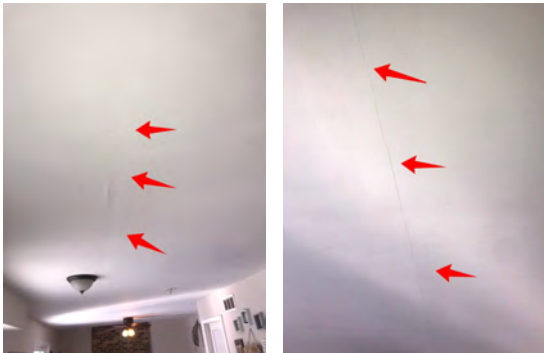
Kitchen

Settlement crack with signs of past moisture along the tapping of the ceiling drywall.

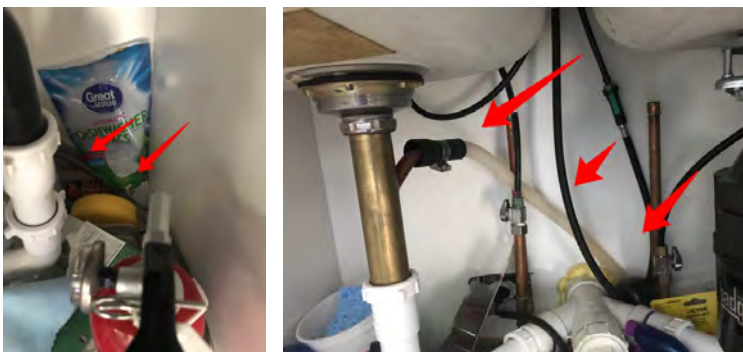
Kitchen: Appliances

A high drain loop is needed to be installed 32" above the floor level or an air gap must be installed. To prevent a back flow of dirty water entering the dishwasher.

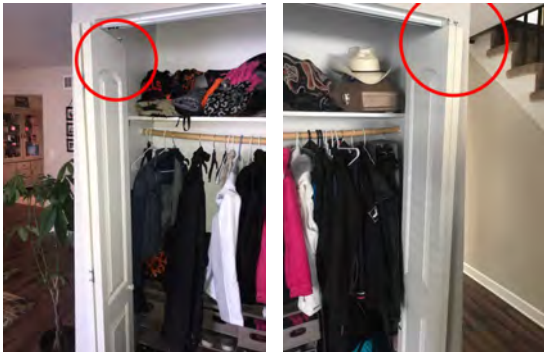
Living Room

the closet folding doors are off their track and damaged.

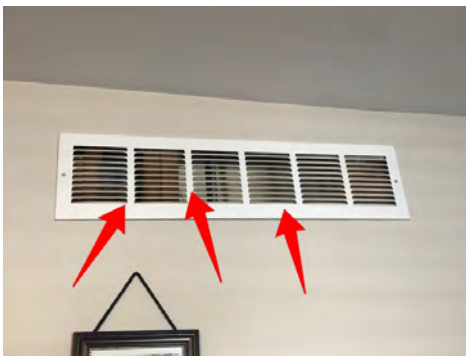
Living Room

The return vent opening is larger than the vent, allowing heat to escape between the drywalls.

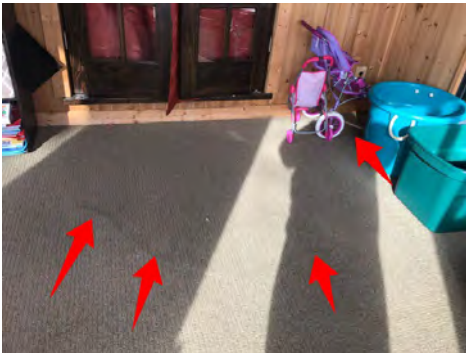
Signs of water penetration under the carpet of the sun room.

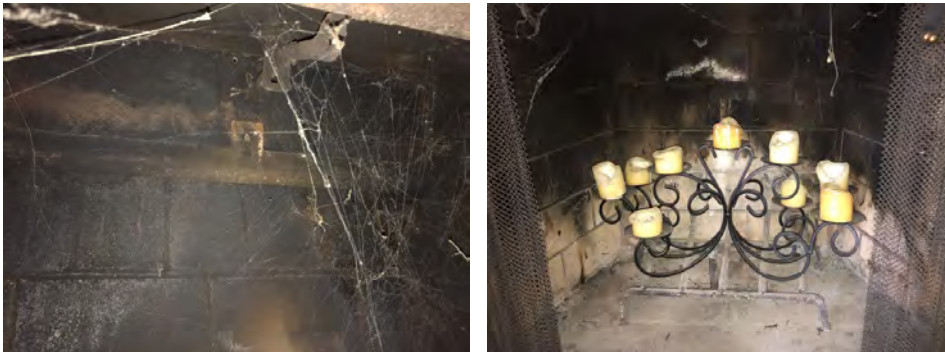
Recommend a professional to clean and evaluate the fireplace before usage. There is a build up of soot along the walls.

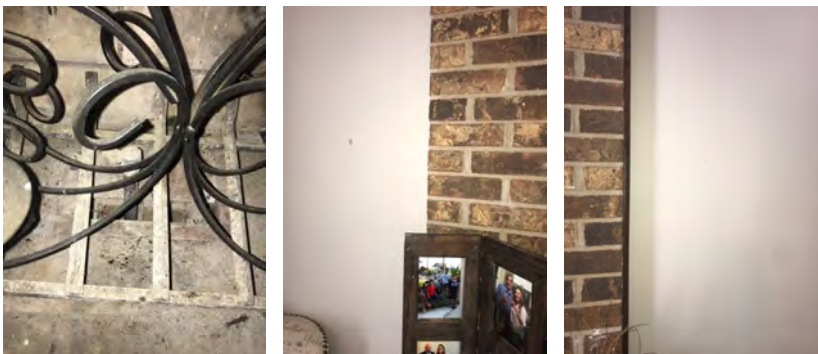
Family Room: Fireplace

A gas supply pipe is installed with in the ash pit but no Gas Starter Access was discovered.

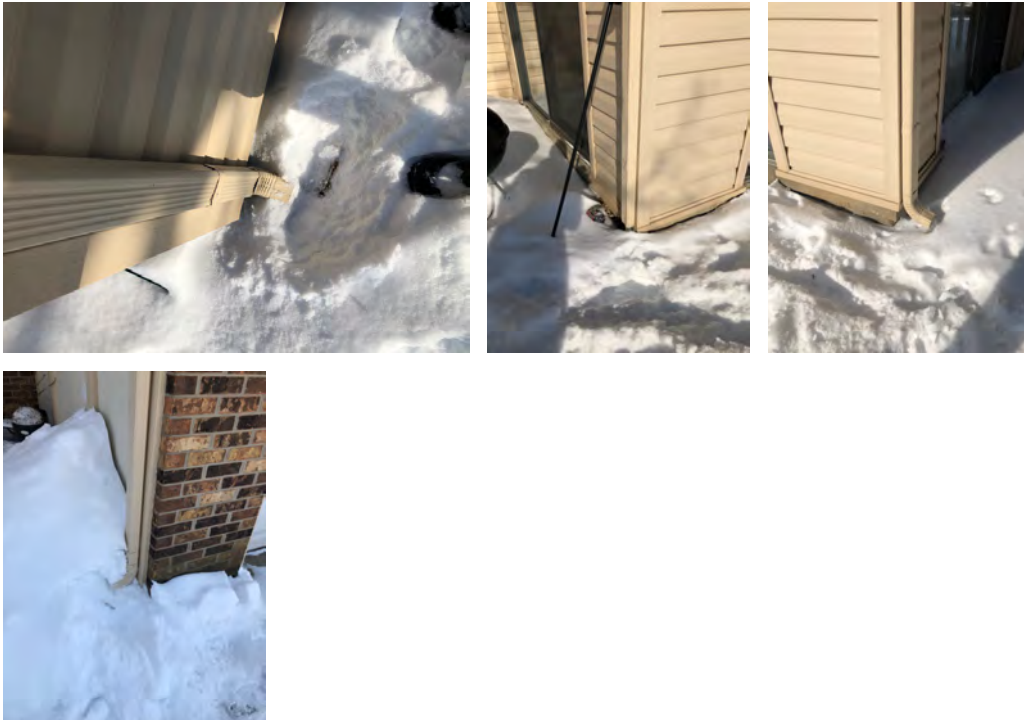
Downspouts should extend a min of 4-6' from the structure to reduce the risk of water penetration, settlement and structural damage. Evidence of water infiltration noted in crawlspace.

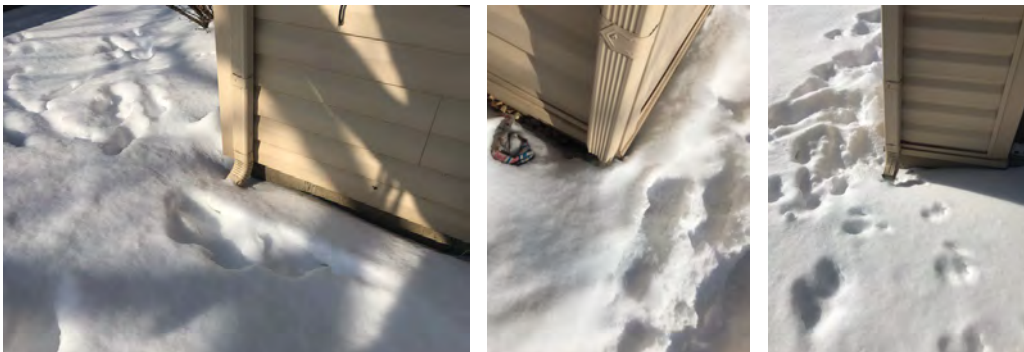
Comment 2

Downspout needs to be extended 6' away from the property to prevent water infiltrating the foundation.

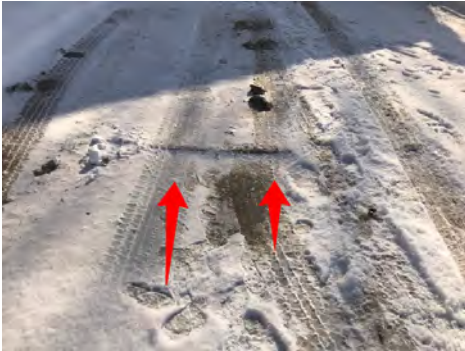
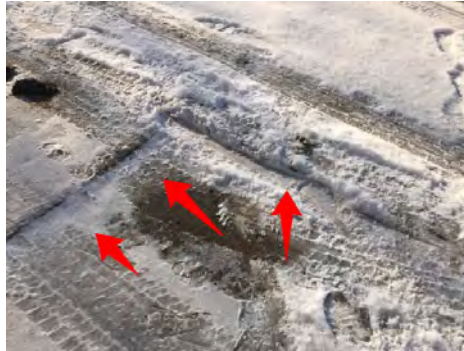
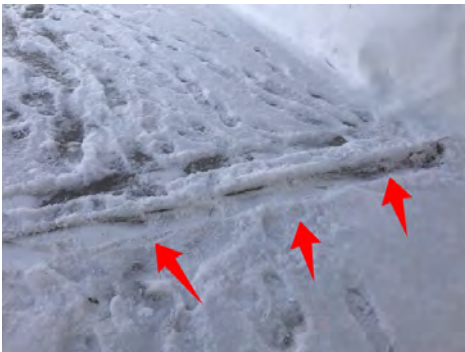
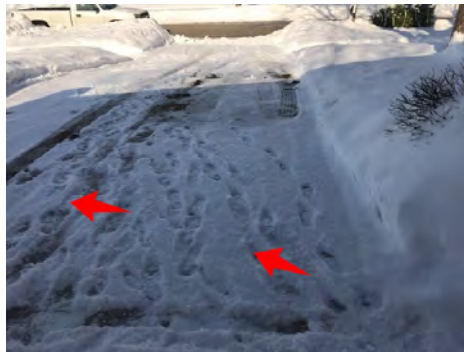
The driveway expansion joint that separates concrete slabs are not sealed properly. Resulting in movement of the slabs due to frost heaving and becoming a trip hazard.

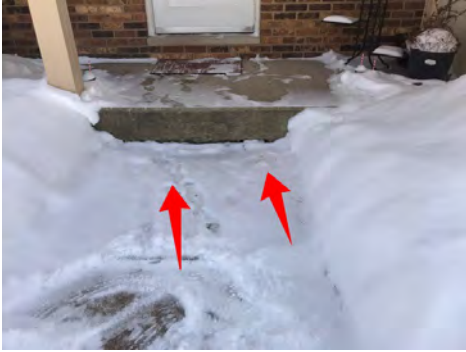
Comment 4

A negative grading in front walkway of the home is leading water towards the front stoop and foundation.

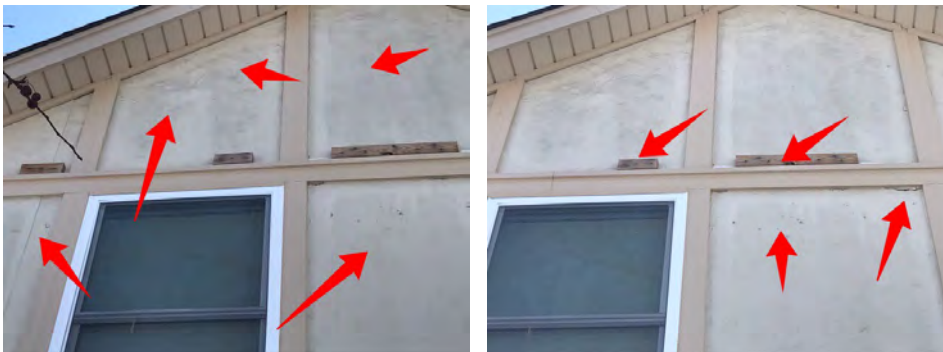
Comment 6 Deficiency

Damage to the front stucco and wood planks (2" x 4") are nailed to front stucco. We Recommend having a licensed professional to evaluate before closing. See attic section.

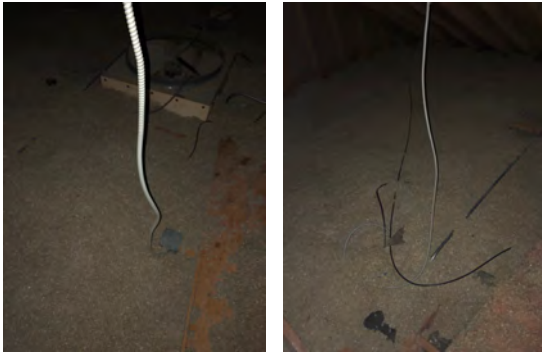
Electrical wires should be supported by proper hangers.

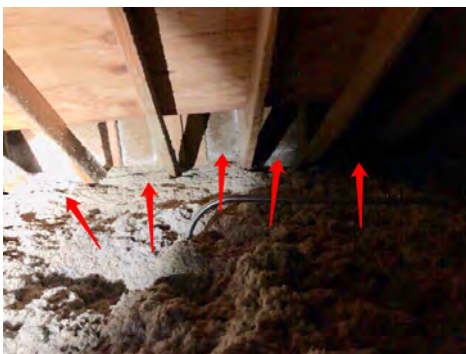
**Comment 8
Deficiency**

There is frost buildup on the front wall of the attic. Damage to the front exterior in this area has been temporarily repaired with 2x4 boards. We recommend the front of the home and this section of attic be evaluated for repair by a qualified building contractor to prevent further water damage.

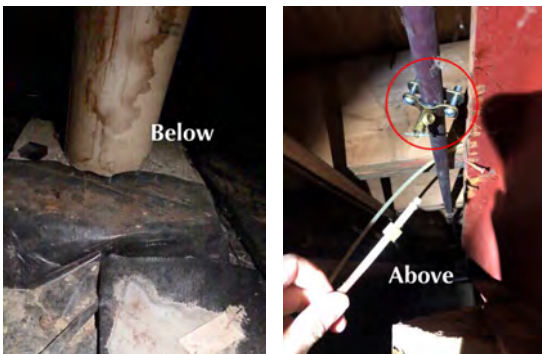
There is a saddle valve that is not in use. Saddle valves are commonly used for refrigerator ice maker water supply but they are inherently unreliable. There is evidence of past water leaks below. Area was dry at the time of the inspection.

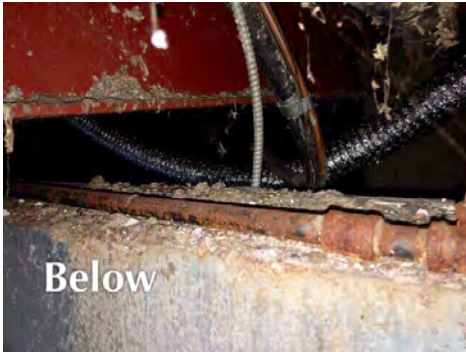
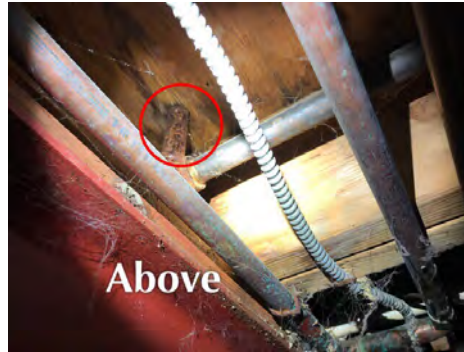
Comment 11
Information

There is a rusty gas pipe and evidence of a past water leak. Dry when inspected.

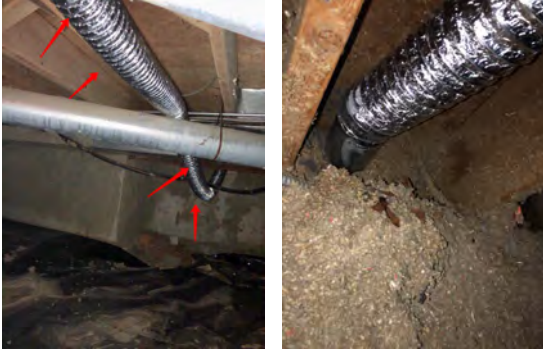
Comment 13
Deficiency

Dryer vents should have smooth metal interior to reduce the risk of lint buildup and allow for routine cleaning. Dryer lint is a combustible material. Dryer exhaust ducts should be kept clean for safety.

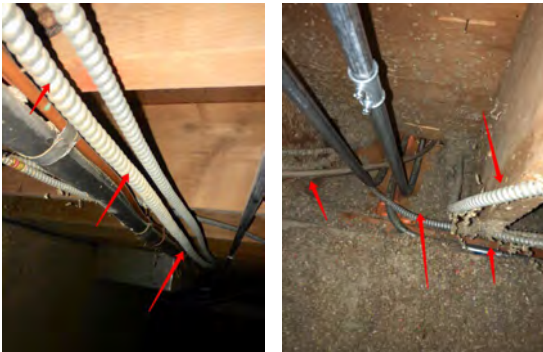
Comment 14
Information

There are lengths of armored (BX) electrical wires that are not properly supported. We recommend electrical branch wiring in the crawlspace be evaluated by a qualified electrician.

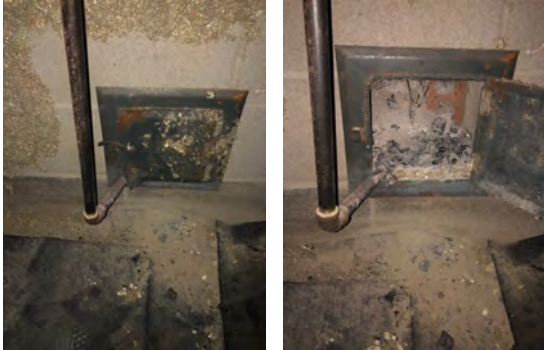
Comment 15

The gas line feeding the west fireplace has no accessible shutoff.

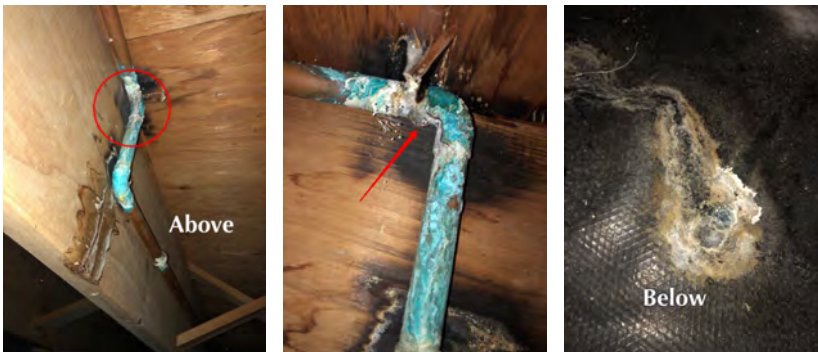
Comment 16

There is an active leak and heavy corrosion on a copper water supply pipe in the south central part of the crawlspace. We recommend all water supply fittings in the crawlspace be evaluated by a licensed plumber. Active leaks should be repaired promptly.

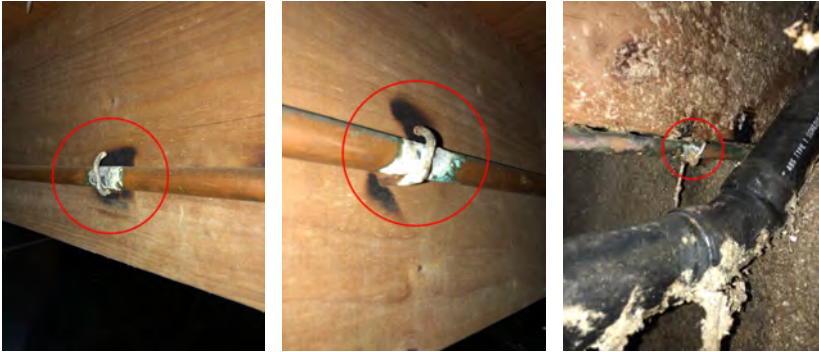
Comment 17
Deficiency

There is galvanic corrosion on the water pipes at numerous joints and fasteners. We recommend all visible water pipes be evaluated by a qualified plumber. Any improper hangers should be replaced with correct ones to reduce the risk of electrolysis and eventual leaks.

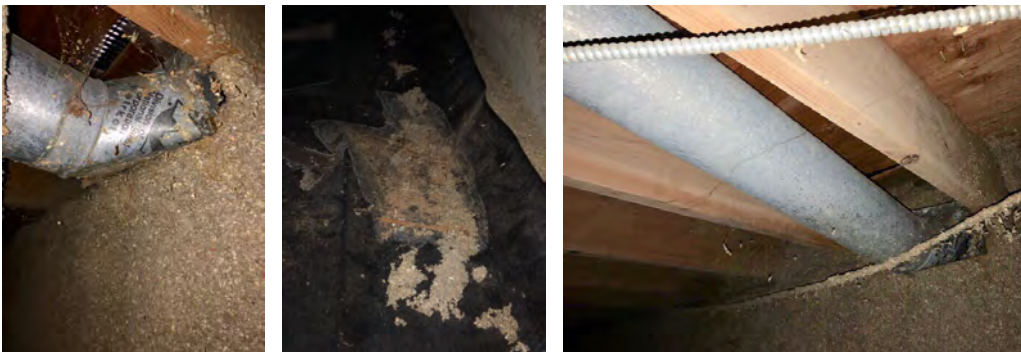
Comment 18
Deficiency

There are loose, poorly supported and uninsulated HVAC ducts in the crawlspace. Signs of water below ducts can indicate poor management of condensate runoff. We recommend ductwork be evaluated by a licensed HVAC professional. See comments on HVAC "distribution" section of report.

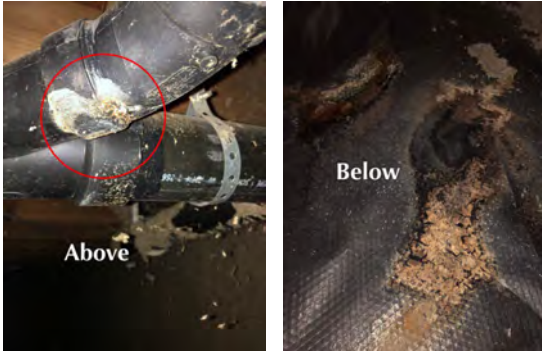
Comment 19
Deficiency

There is a leak at a union in the black waste line in the crawlspace. We recommend evaluation for repair by a qualified plumber.

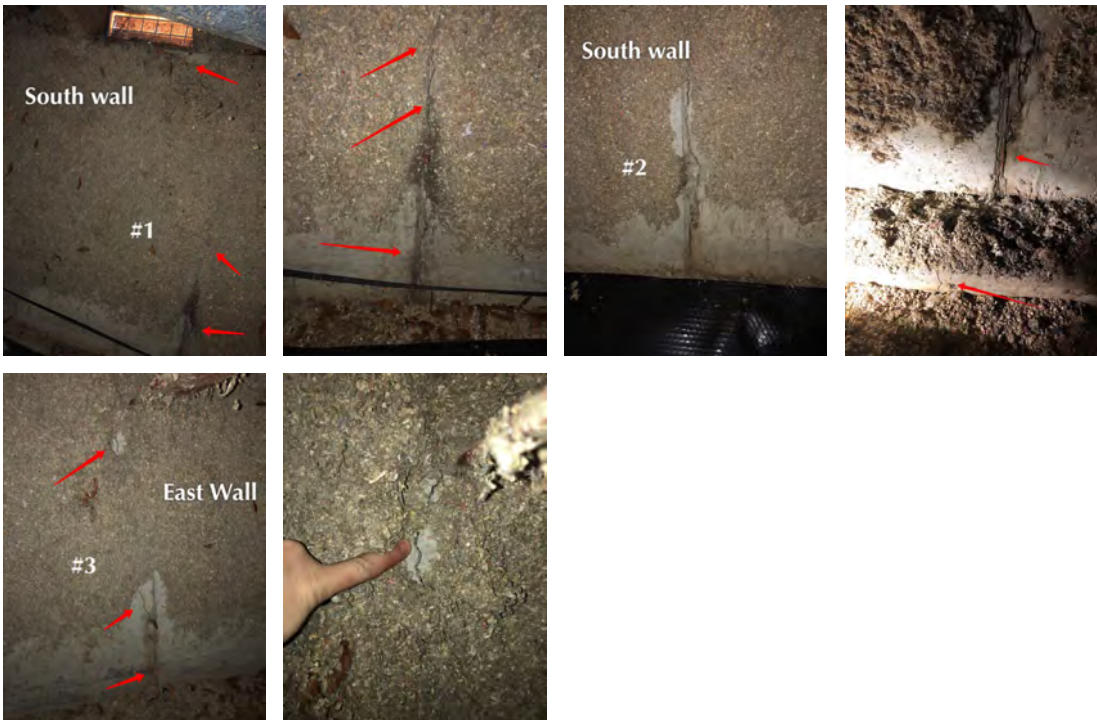
Comment 20
Deficiency

There are 3 or more cracks in the foundation. These should be evaluated for repair by a qualified basement waterproofing/structural professional.

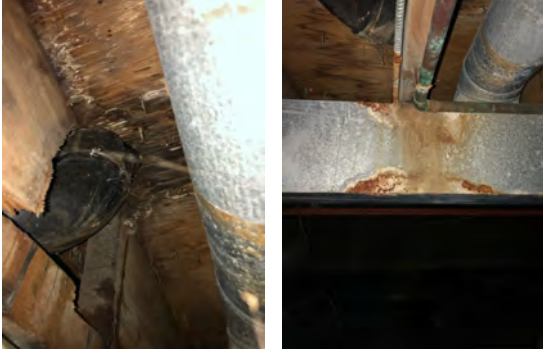
Comment 21
Deficiency

The main floor toilet is loose and leaking on to the HVAC ductwork below. We recommend repair by a qualified plumber and professional cleaning of the ductwork.

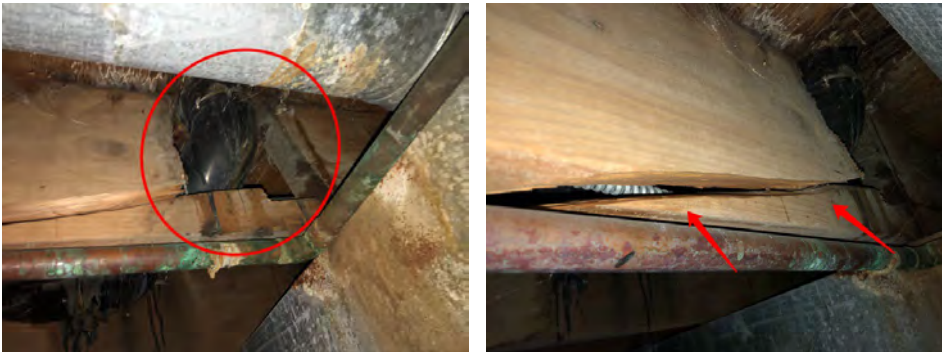
Comment 22
Deficiency

The joist below the main floor toilet has been improperly notched to accommodate the waste drain. The remaining joist has split through. This should be evaluated by a qualified building contractor prior to repairs of the toilet.

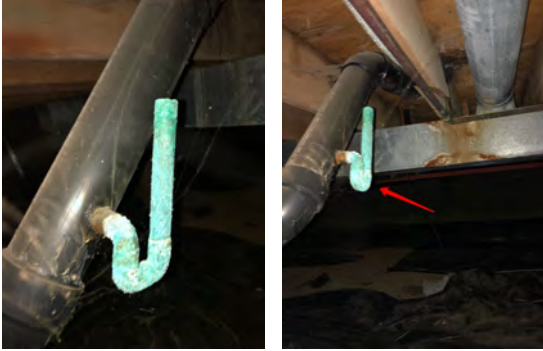
Comment 23
Deficiency

There is an incorrectly installed p-trap/vent in the main waste drain. This should be removed by a qualified plumber to prevent toxic sewer gasses from entering the crawlspace.

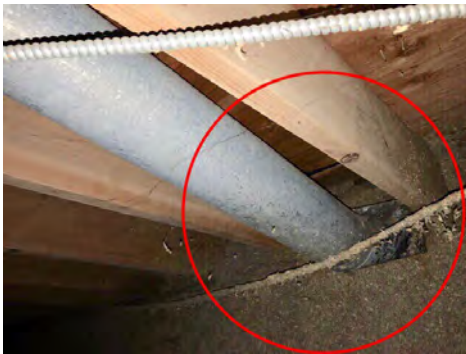
One of the supply ducts in the crawlspace is not correctly installed. Conditioned air is being supplied to the crawlspace rather than the kitchen heat register above. We recommend the ductwork in the crawl space be evaluated by a HVAC professional.

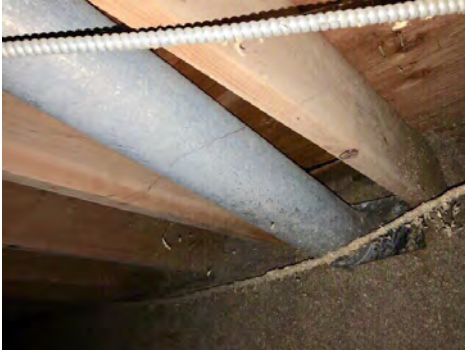
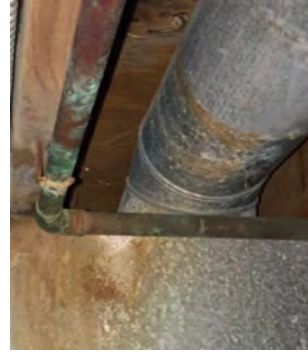
Comment 29
Information

Recommend ductwork in all unconditioned spaces be insulated for a more efficient distribution.

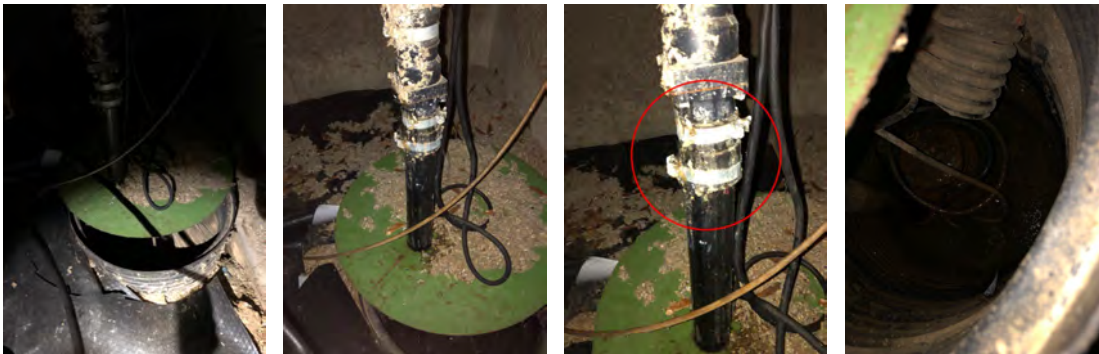
The check valve in the sump drain line is leaking.

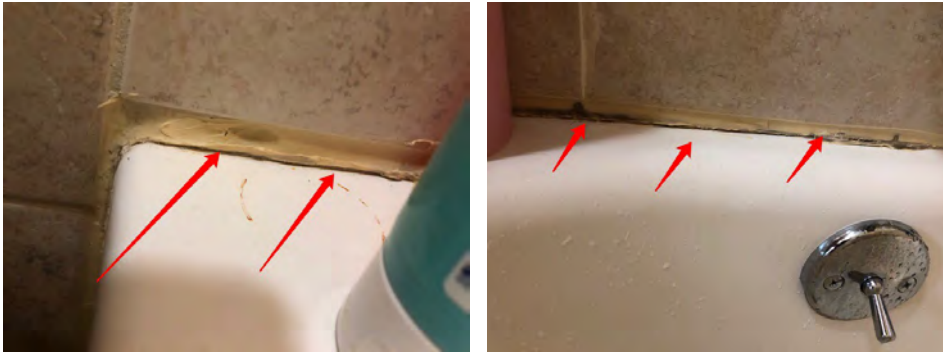
There is failing caulk where the tub meets the wall.

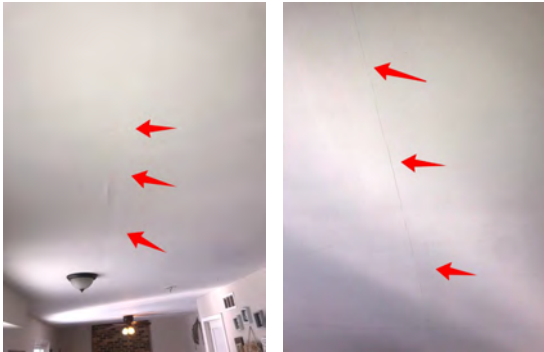
Comment 38
Deficiency

Settlement crack with signs of past moisture along the tapping of the ceiling drywall.

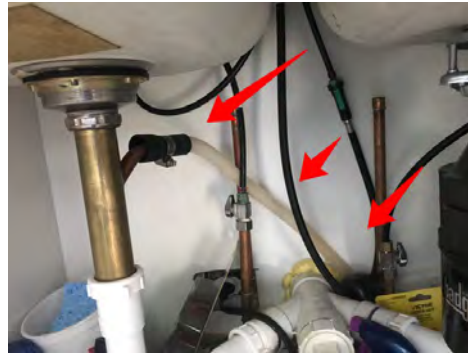
A high drain loop is needed to be installed 32" above the floor level or an air gap must be installed. To prevent a back flow of dirty water entering the dishwasher.

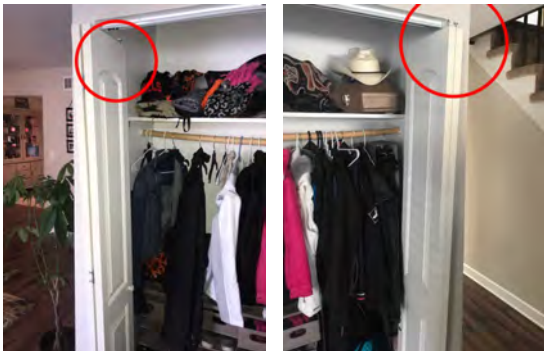
the closet folding doors are off their track and damaged.

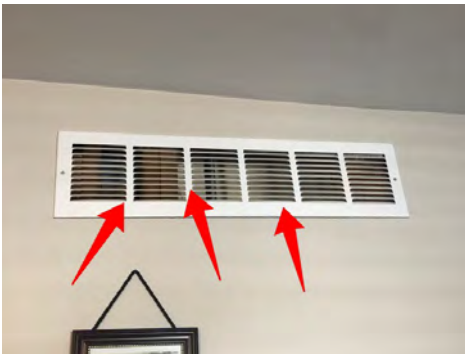
The return vent opening is larger than the vent, allowing heat to escape between the drywalls.

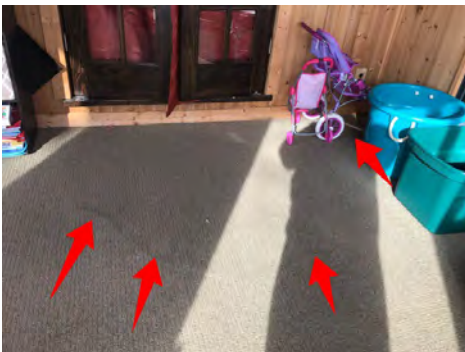
Signs of water penetration under the carpet of the sun room.

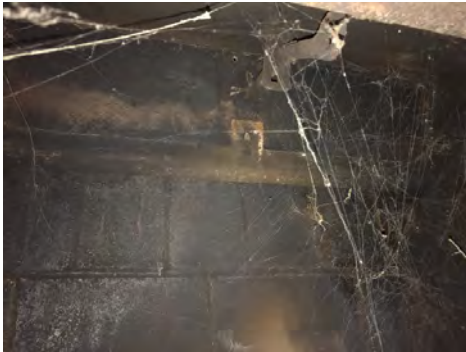
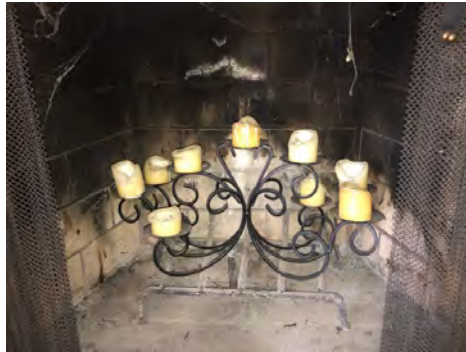
Recommend a professional to clean and evaluate the fireplace before usage. There is a build up of soot along the walls.

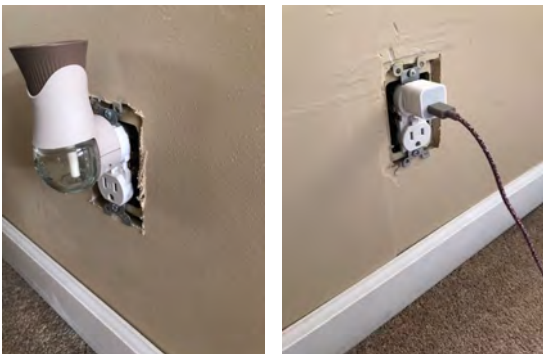
There are missing switch plates.

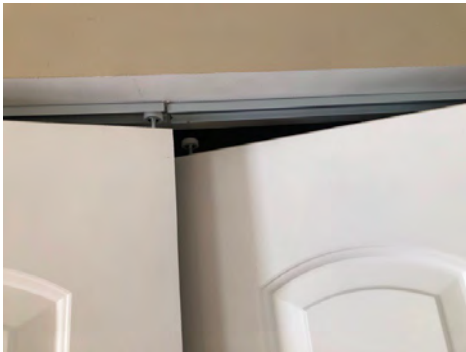
The closet doors are loose.
