Property

649 Wood Dr.
Glenview, IL 60022

Date & Time

02/01/2019 1:00 pm

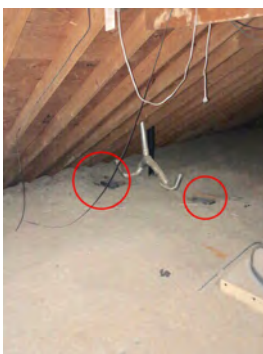
Structure: Attic

The bathroom exhaust vents have been detached from the ductwork. Bath vents should be ducted to the outdoors to reduce the risk of moisture and mold problems.

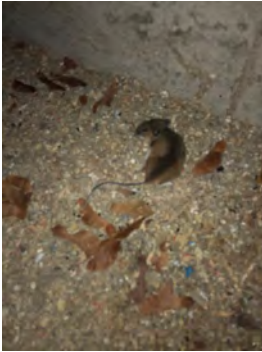
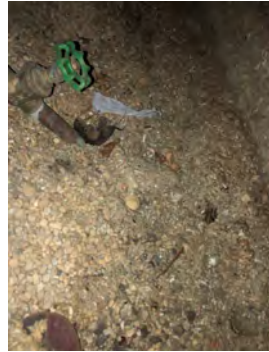
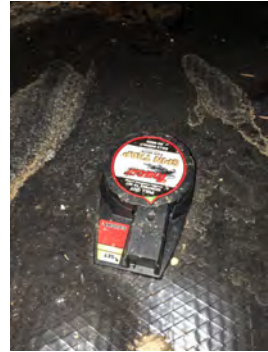
Structure: Crawlspace

There is evidence of rodent activity. We recommend evaluation by a pest control professional.

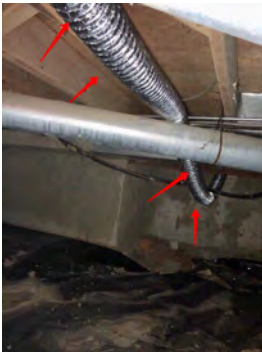
Structure: Crawlspace

Dryer vents should have smooth metal interior to reduce the risk of lint buildup and allow for routine cleaning. Dryer lint is a combustible material. Dryer exhaust ducts should be kept clean for safety.

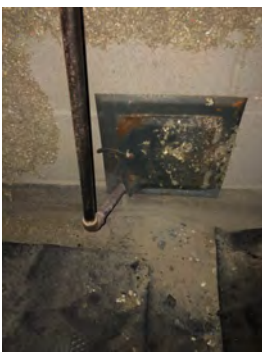
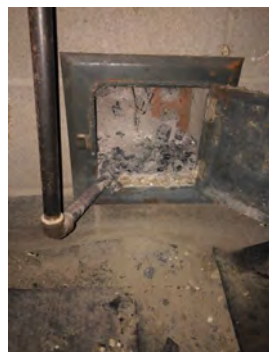
Structure: Crawlspace

The gas line feeding the west fireplace has no accessible shutoff.

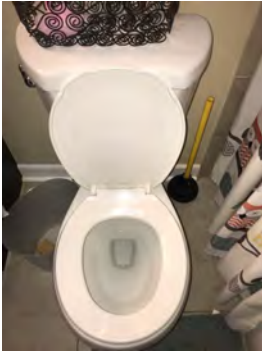
Bathrooms: Bathroom #2

The toilet is loose at the floor and requires sealant at the base.

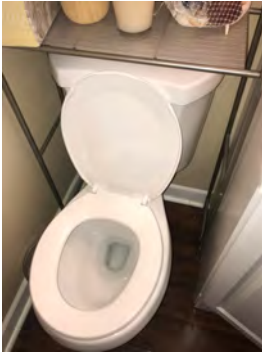
Bathrooms: Half Bathroom

The toilet is loose at the floor and requires sealant at the base.

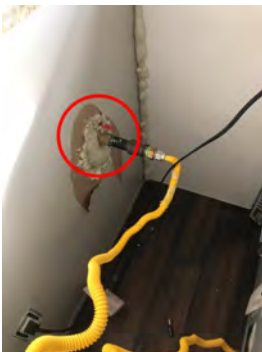
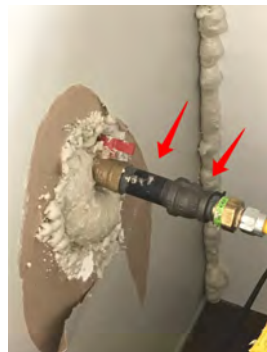
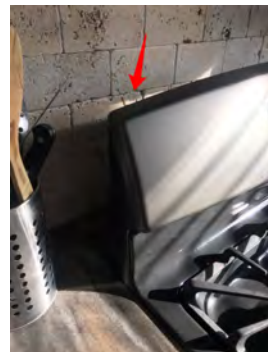
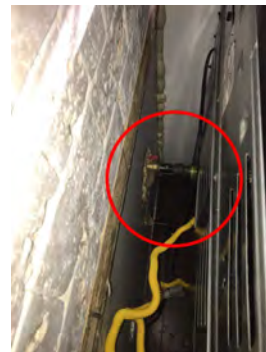
Kitchen

The shut off valve for the stove gas line is inoperable. The black pipe gas line is too long and obstructing the stove from seating flush.

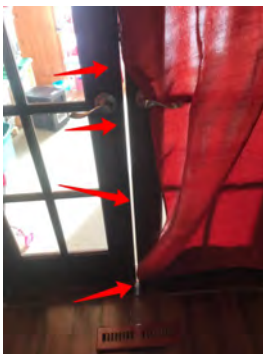
Dining Room

The french doors leading to sun room are interior doors with a large gap, allowing heat to escape to the sun room. The sun room is not heated nor has proper insulation. We recommend having a sealed exterior grade door to prevent the huge heat loss.

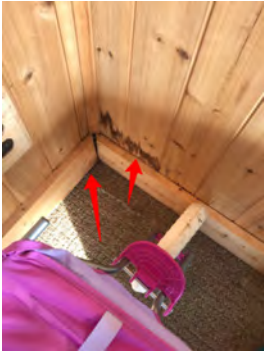
Sun Room

Signs of water penetration on the northeast side of the sun room.

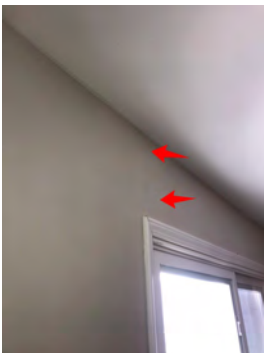
Family Room

Settlement crack in the south wall.

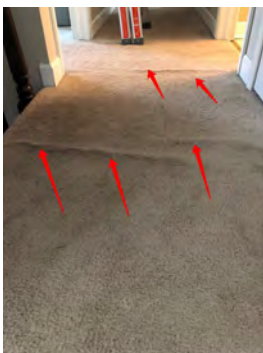
Hallway

Bunched carpet at the top of the stairs is a potential trip hazard. The carpet should be re-stretched.

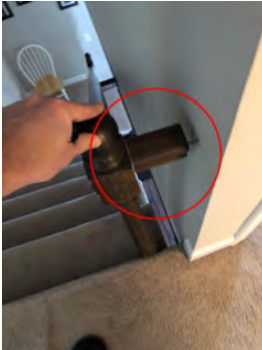
Stairs

The handrail is loose.

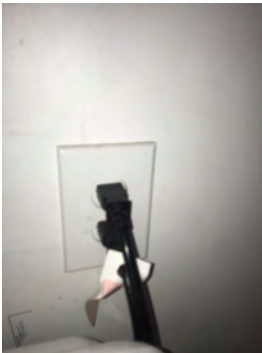
Laundry

Ground fault circuit interrupter (GFCI) outlets needed in laundry area.

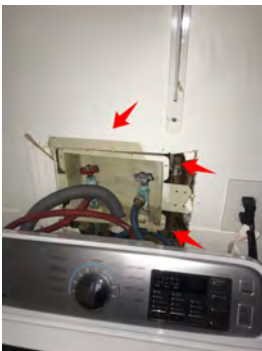
Laundry

Framing and drywall around the laundry hook up is damaged and exposing pipes.

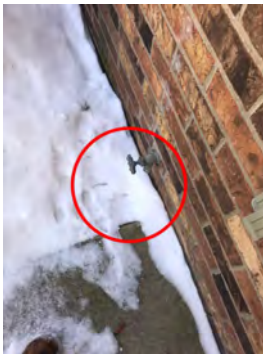
Comment 5 Information

No anti-siphon device discovered on spigots. This could lead to cross contamination.

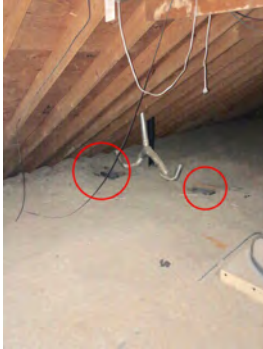
Comment 9
Deficiency

The bathroom exhaust vents have been detached from the ductwork. Bath vents should be ducted to the outdoors to reduce the risk of moisture and mold problems.

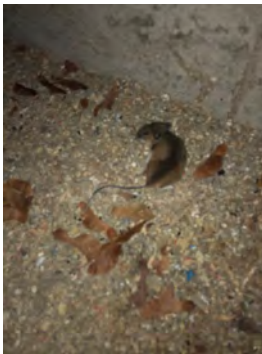
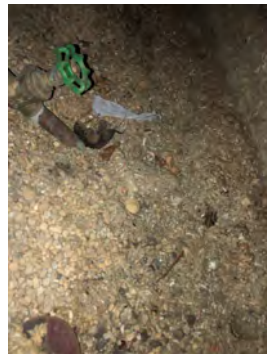
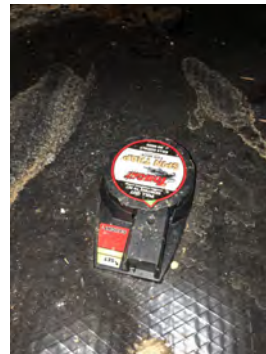
Comment 12
Deficiency

There is evidence of rodent activity. We recommend evaluation by a pest control professional.

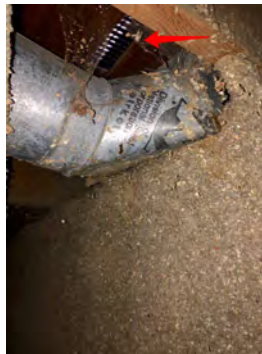
One of the supply ducts in the crawlspace is not correctly installed. Conditioned air is being supplied to the crawlspace rather than the kitchen heat register above. We recommend the ductwork in the crawl space be evaluated by a HVAC professional.

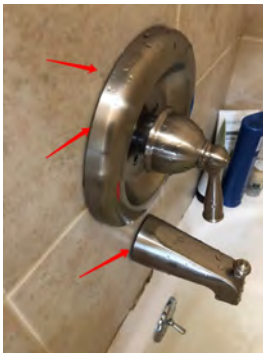
Comment 32

Gaps in the shower wall should be sealed with a proper silicone caulk to prevent water damage behind the wall.

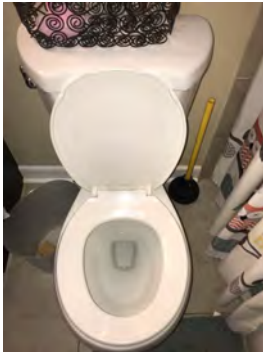
The toilet is loose at the floor and requires sealant at the base.

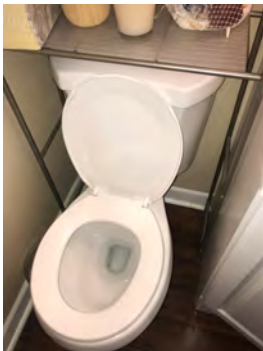
The toilet is loose at the floor and requires sealant at the base.

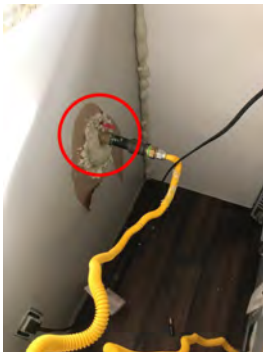
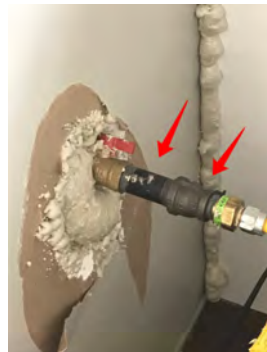
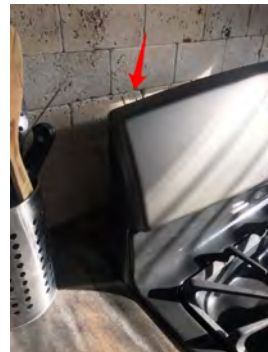
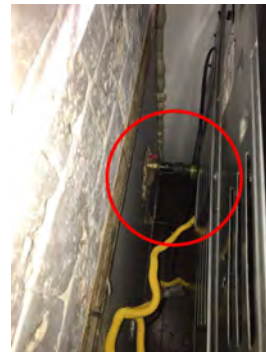
The shut off valve for the stove gas line is inoperable. The black pipe gas line is too long and obstructing the stove from seating flush.

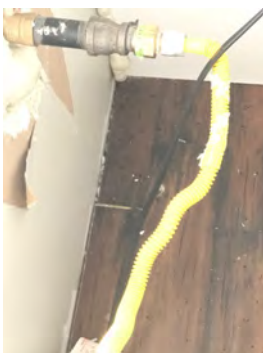
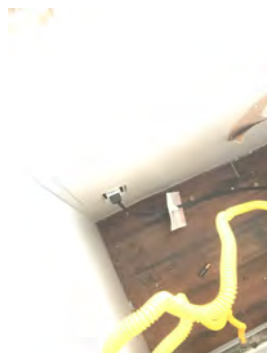
Comment 37

Signs of rodents /mice dropping behind the stove. Recommend having a licensed exterminator to evaluate.

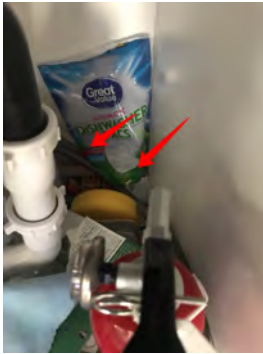
A high drain loop is needed to be installed 32" above the floor level or an air gap must be installed. To prevent a back flow of dirty water entering the dishwasher.

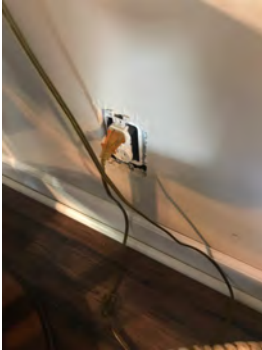
East wall outlet is missing a cover plate.

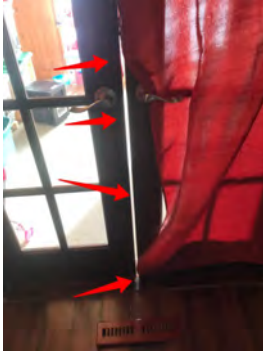
The french doors leading to sun room are interior doors with a large gap, allowing heat to escape to the sun room. The sun room is not heated nor has proper insulation. We recommend having a sealed exterior grade door to prevent the huge heat loss.

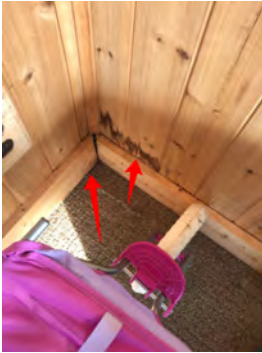
Signs of water penetration on the northeast side of the sun room.

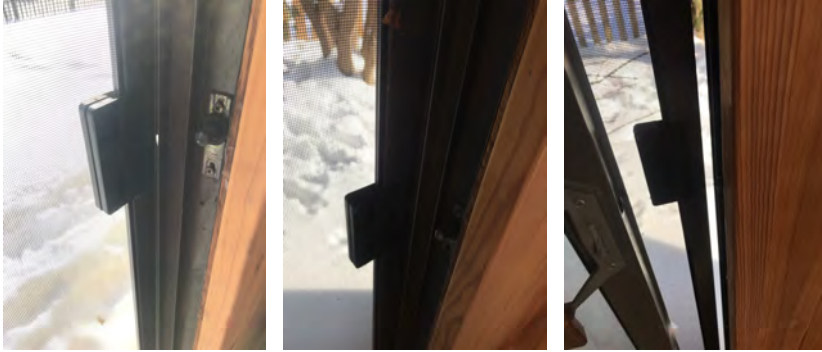
Comment 46
Information

All three sliding screen doors do not latch.

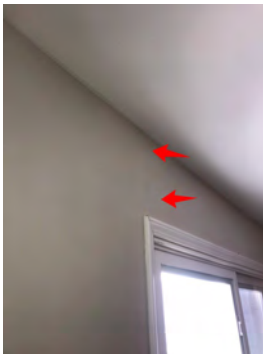
Settlement crack in the south wall.

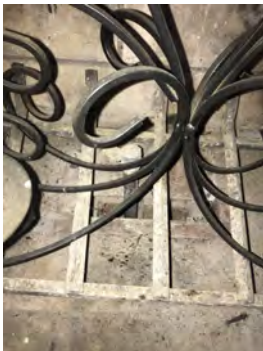
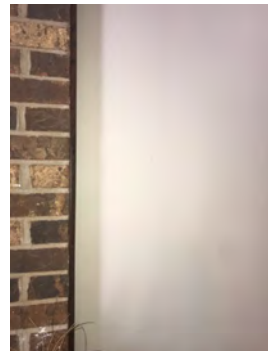
A gas supply pipe is installed with in the ash pit but no Gas Starter Access was discovered.

Interior of flues and chimneys are impossible to fully view. A chimney professional should evaluate the flue and the chimney prior to the closing.

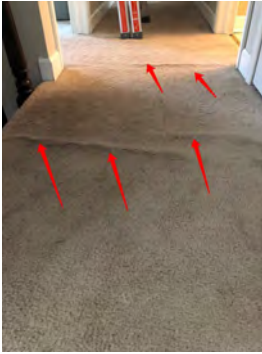
Bunched carpet at the top of the stairs is a potential trip hazard. The carpet should be re-stretched.

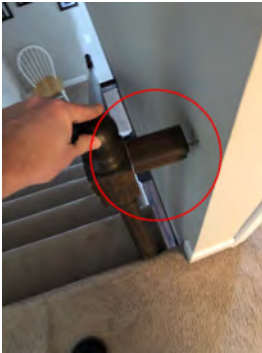
The handrail is loose.

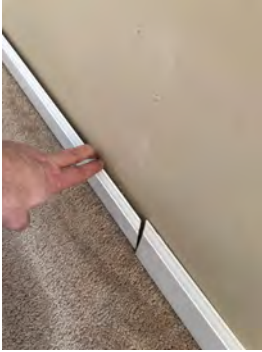
Comment 53
Information

The baseboards are loose.

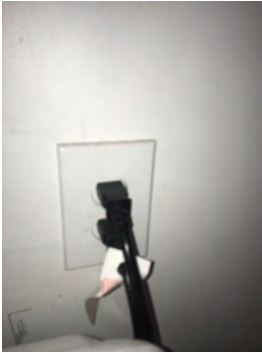
Ground fault circuit interrupter (GFCI) outlets needed in laundry area.

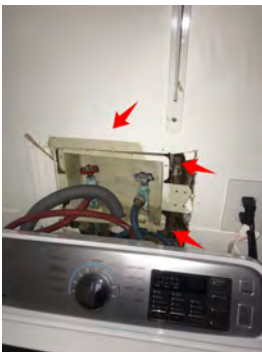
Comment 57

Framing and drywall around the laundry hook up is damaged and exposing pipes.
